**DEPARTMENT OF TRANSPORTATION**

Contract #: 04-0120F4Cty: SF/ALA Rte: 80 PM: 13.2/13.9File #: 69.28**WELDING INSPECTION REPORT****Resident Engineer:** Pursell, Gary**Address:** 333 Burma Road**City:** Oakland, CA 94607**Report No:** WIR-013626**Date Inspected:** 21-Apr-2010**Project Name:** SAS Superstructure**OSM Arrival Time:** 700**Prime Contractor:** American Bridge/Fluor Enterprises, a JV**OSM Departure Time:** 1900**Contractor:** Zhenhua Port Machinery Company, Ltd (ZPMC), Changxing Island **Location:** Shanghai, China**CWI Name:** Li Yang**CWI Present:** Yes No**Inspected CWI report:** Yes No N/A**Rod Oven in Use:** Yes No N/A**Electrode to specification:** Yes No N/A**Weld Procedures Followed:** Yes No N/A**Qualified Welders:** Yes No N/A**Verified Joint Fit-up:** Yes No N/A**Approved Drawings:** Yes No N/A**Approved WPS:** Yes No N/A**Delayed / Cancelled:** Yes No N/A**Bridge No:** 34-0006**Component:** OBG**Summary of Items Observed:**

## WELDING INSPECTION REPORT

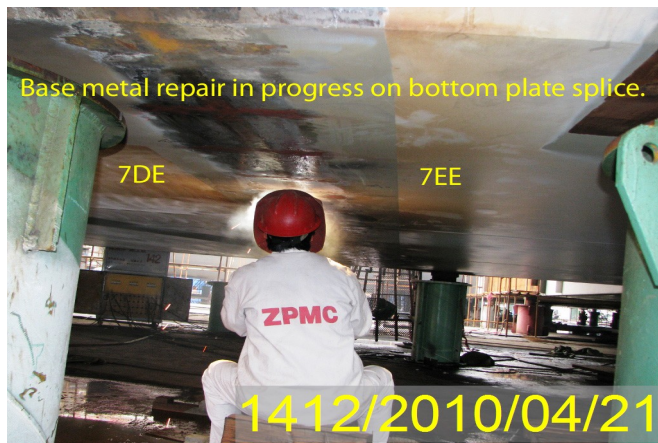
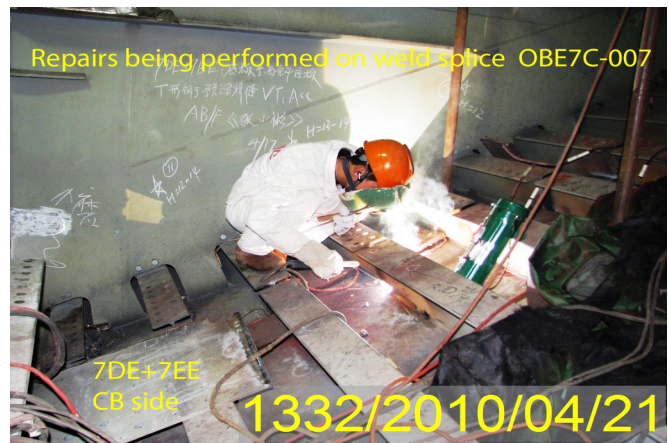
Unless otherwise noted, all work observed on this date appeared to generally comply with applicable contract documents.
